NRL Memorandum Report 1950

AD 633 633 633
**Analysis of the Failure of the
AUTEC TOTO II Deep Sea Moor and the
Performance of its Cathodic Protection System**

R. E. GROOVER

November 1968

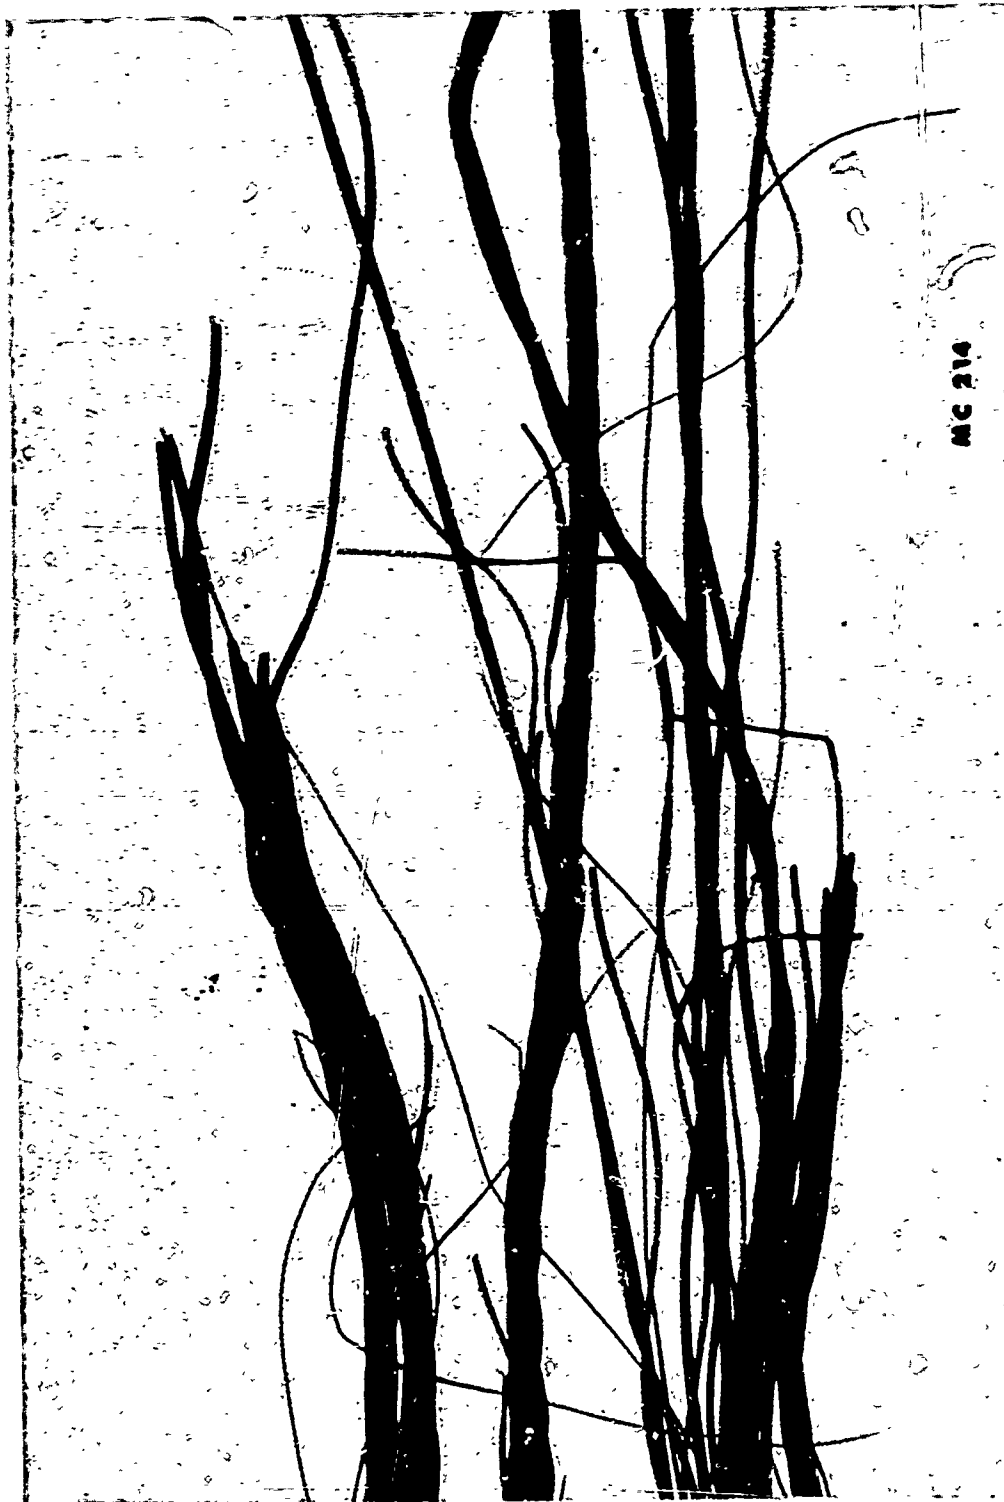
MC 214

Multiple broken wires and a failure of the wire rope occurred 680 ft from the lower anode connection on the 270° lower catenary. The wire rope was severely corroded at and above the point of failure (Fig. 2). All other multiple broken wires and failures were at least 1000 ft from the nearest anode connection. Field observations relative to broken wires are given in Table 1.

Fig. 2 - Failure of the 270° leg lower catenary 680 ft from the nearest intended anode connection. The 400 lb anode was probably lost when the moor was laid (based on relative condition of other lower catenaries).
(a) The failed end of the catenary. Many outer wires are missing.

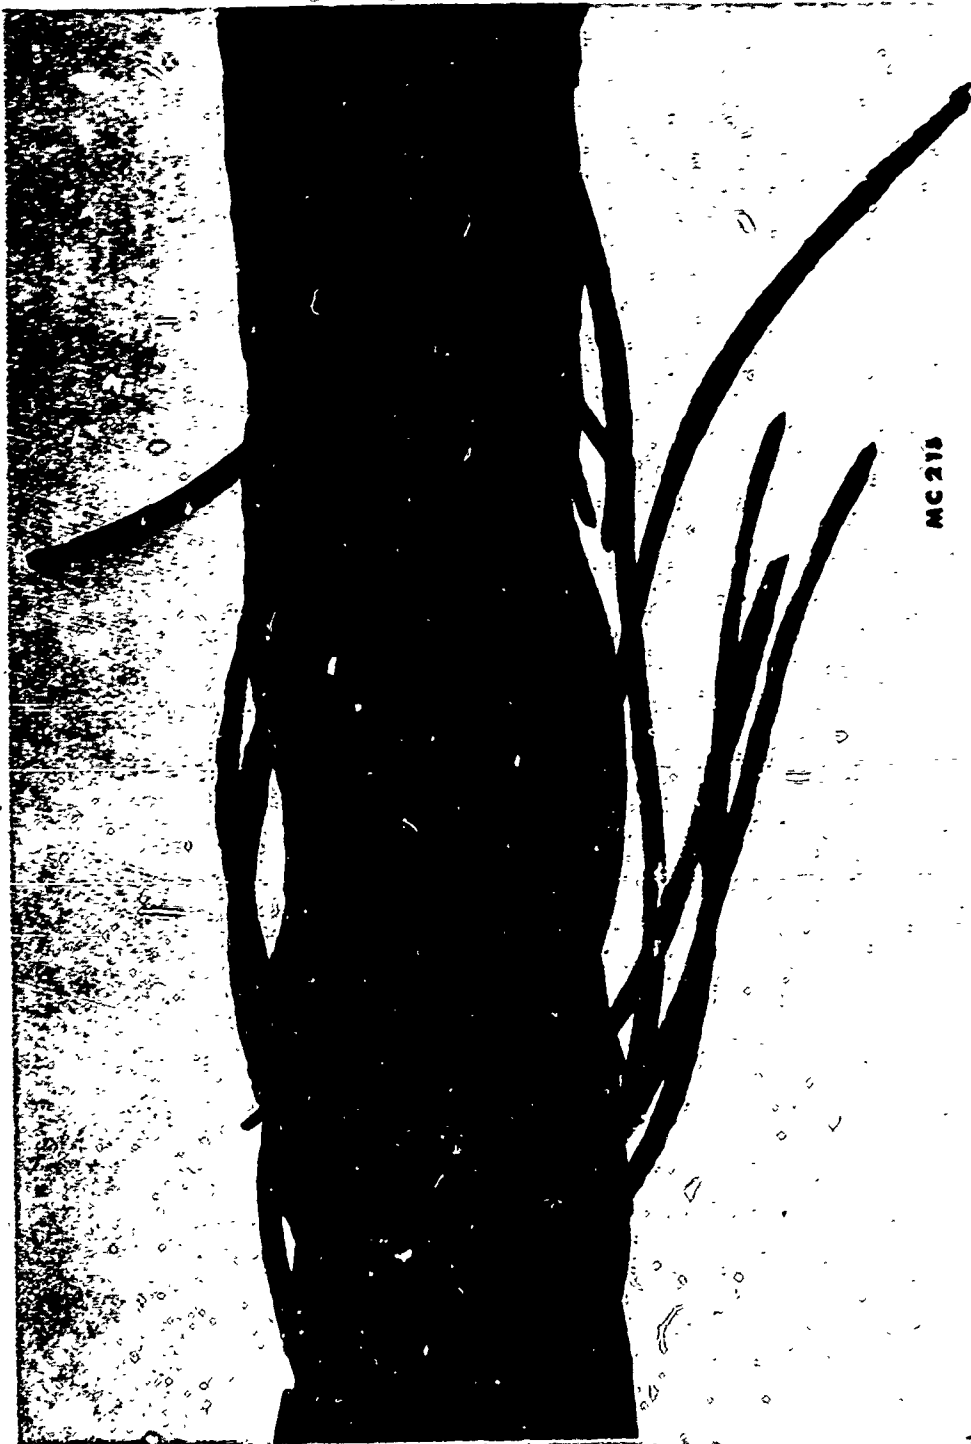
Fig. 2 (continued) - Failure of the 270° leg lower catenary 680 ft from the nearest intended anode connection. The 400 lb anode was probably lost when the moor was laid (based on relative condition of other lower catenaries).
(b) Severe corrosion of the wire rope 21 ft above the failure.

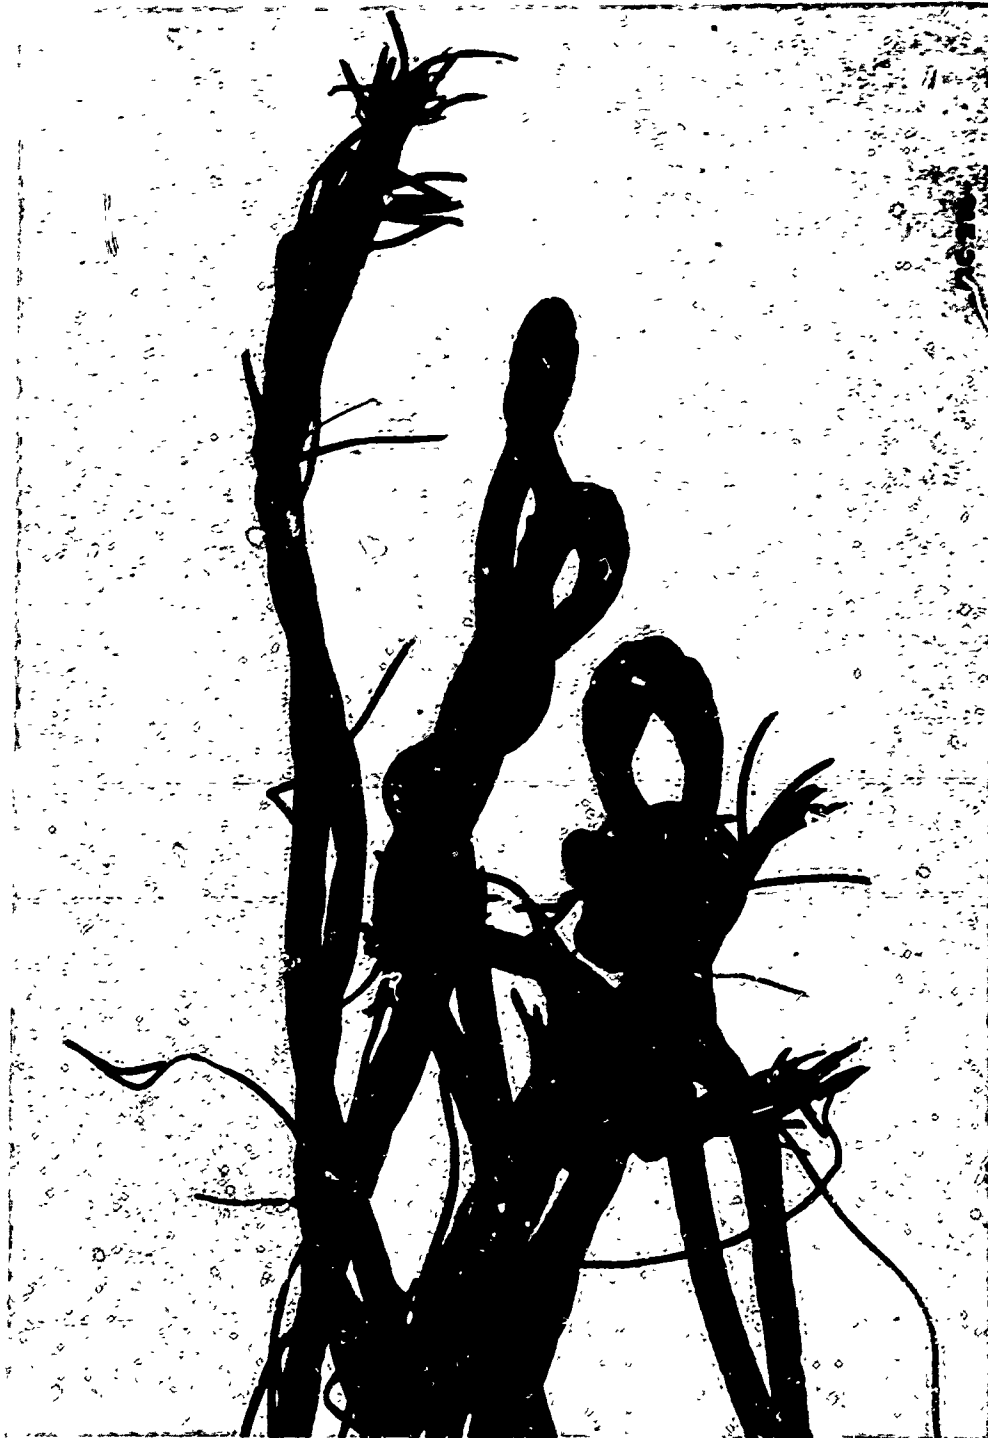
The upper and lower catenaries on the 030° leg failed prior to salvage. Corrosion on the catenaries was not severe and is not believed to have been the cause of the failures. The 25-ft section of the upper catenary in which failure occurred had been twisted prior to failure. Color photographs are available at NRL (Code 6325) which show in detail the twist and failure. The lower catenary appeared to have kinked before or during failure (Fig. 3). It can be surmised that the 030° catenaries failed as a result of ships improperly mooring to the intermediate buoy rather than to the main buoy.

3. The failure of the 1 1/4-in.-diam wire rope upper and lower catenaries on the 030° leg was associated with twists and kinks in the catenaries rather than with severe corrosion. This suggests that these failures may have occurred as a result of a ship improperly mooring to the 030° leg intermediate buoy rather than to the main buoy.

Fig. 3 - Failed end of the 030° leg lower ca-enary 1350 ft from the nearest anode connection. Note twists and kinks; severe corrosion had not occurred.

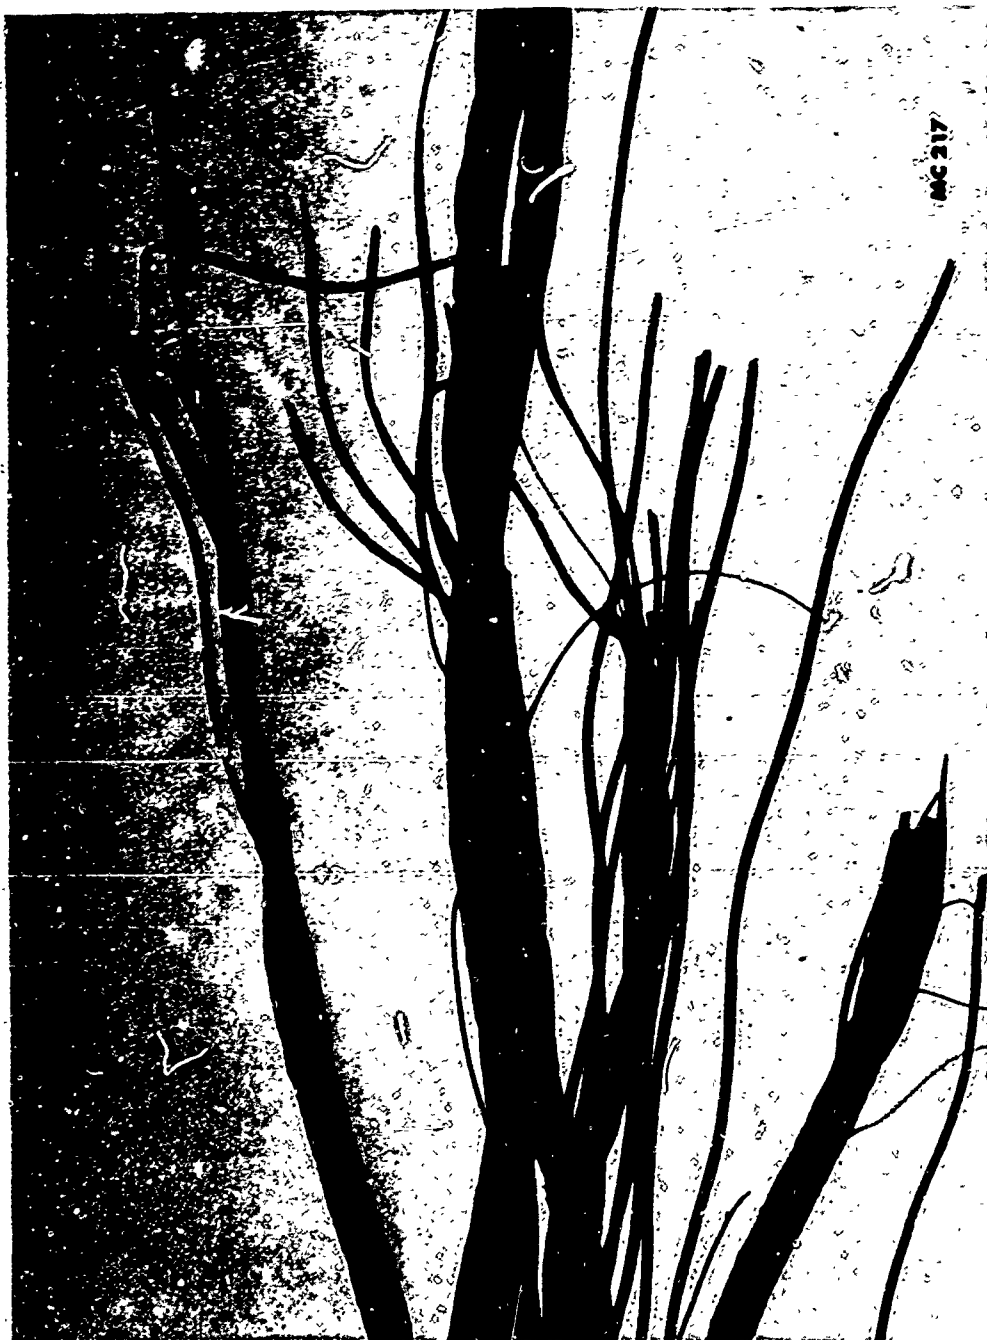
The 270° leg vertical riser failed about 2580 ft below the intermediate buoy. The appearance of the failed end is shown in Fig. 4.

Fig. 4 - Failed end of the vertical riser 2580 ft below the 270° leg intermediate buoy or 1520 ft from nearest anode connection; severe corrosion was evident.

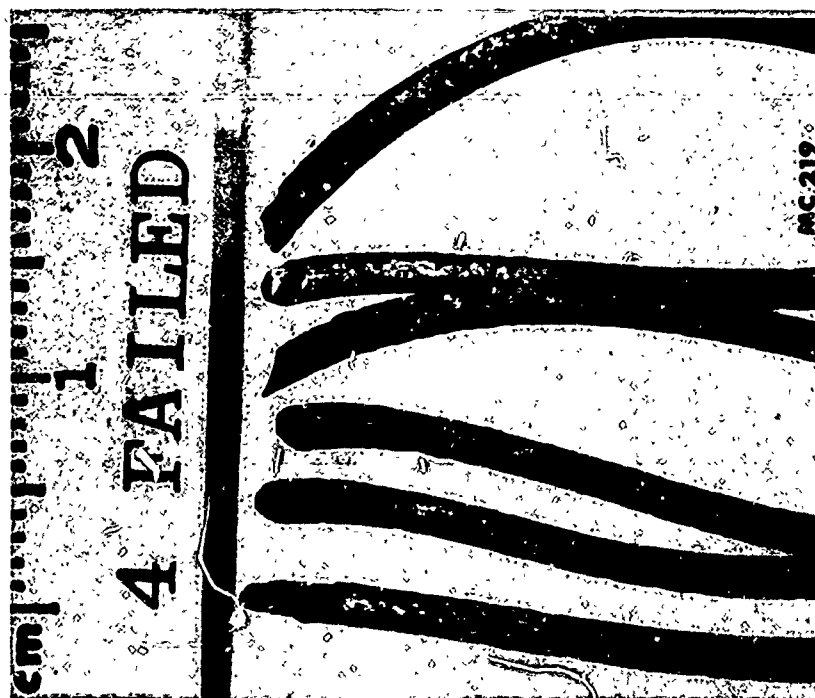
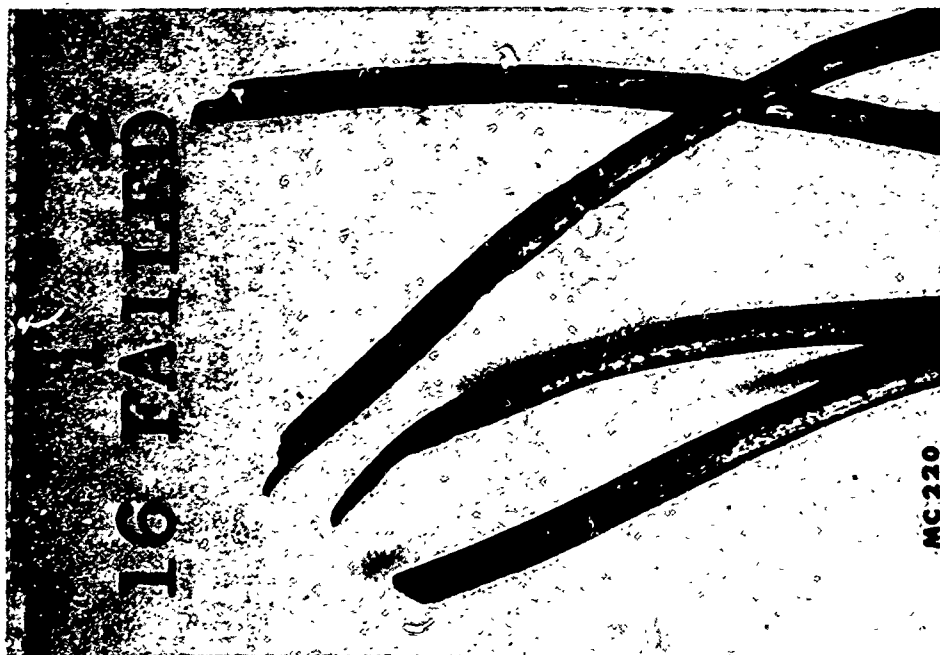
Figure 5 shows that the average minimum diameter of outer wires from the upper catenaries ranged from 53 to 77 mil. The wires having smaller residual diameters were located about 1000 ft from the upper anodes, and those having larger residual diameters were at the lower ends of the catenaries near the 400-lb anode connections. The 030° leg upper catenary twisted and failed at the location shown in the figure. It is apparent that the point of failure was not associated with minimum wire diameter or the point of highest natural stress since both would be towards the upper end of the catenary. The appearance of failed ends of wires from the 030° leg upper catenary is shown in Fig. 6.

Fig. 6 - Failed ends of wires from the 030° upper catenary. Fractures on individual wires varied in appearance and wire diameters were not severely reduced.

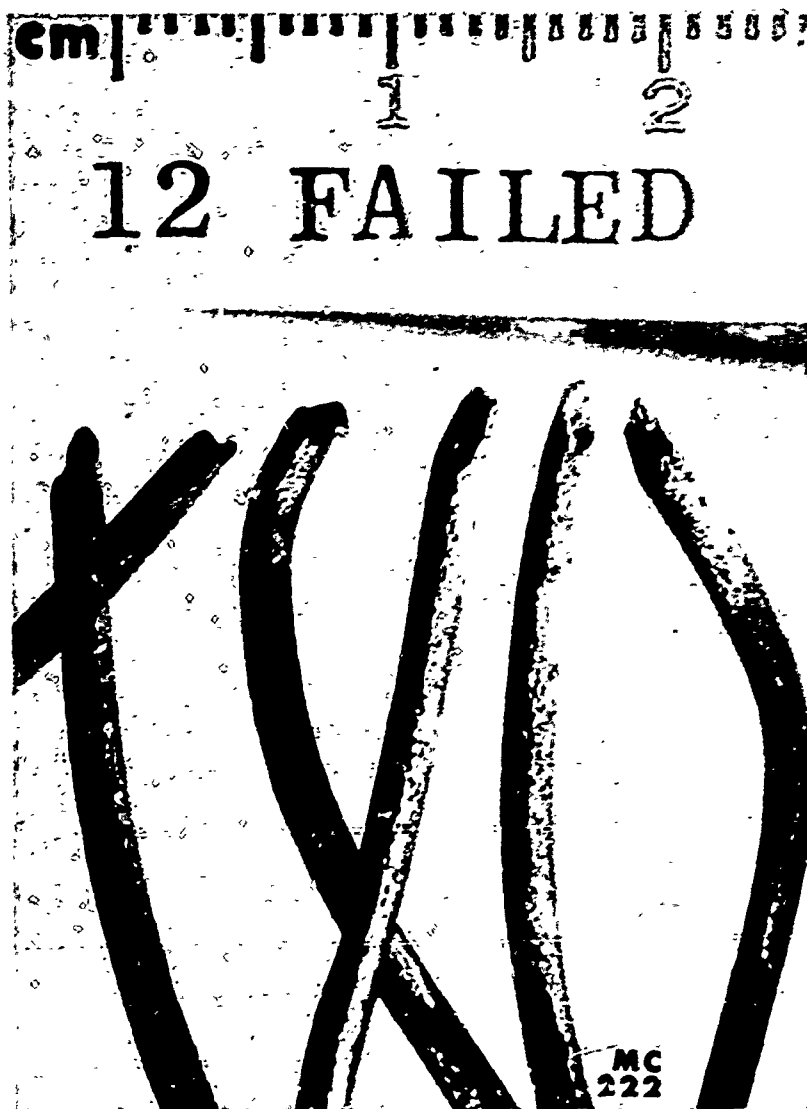
The average minimum diameter of the outer wires of the lower catenary ranged from 0 to 81 mil as shown in Fig. 7. The outer wires from the 270° lower catenary at the point of failure were completely severed by corrosion. Severe corrosion was also noted on the core strand of the 270° lower catenary at this point. Severe reduction of the diameter of the outer wires was not noted on the 030° lower catenary which failed or on the 150° lower catenary. This suggests that the 400-lb anode at the lower end of the 270° lower catenary was lost when the moor was laid and thus permitted severe corrosion to occur. Another significant factor which contributed to the severe corrosion of the 270° lower catenary was the relatively poor coverage of bituminous coating on the strands (Table 2). The appearance of failed ends of wires from the 030° leg lower catenary is shown in Fig. 8.

Fig. 8 - Failed ends of wire from the 030° lower catenary. The fracture appearance on individual wires varied and wire diameters were not severely reduced.

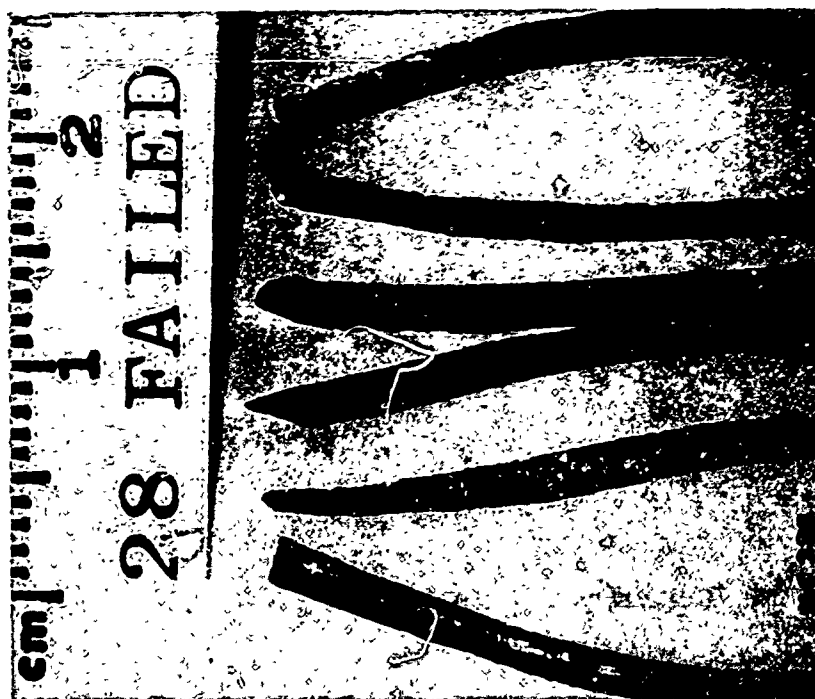
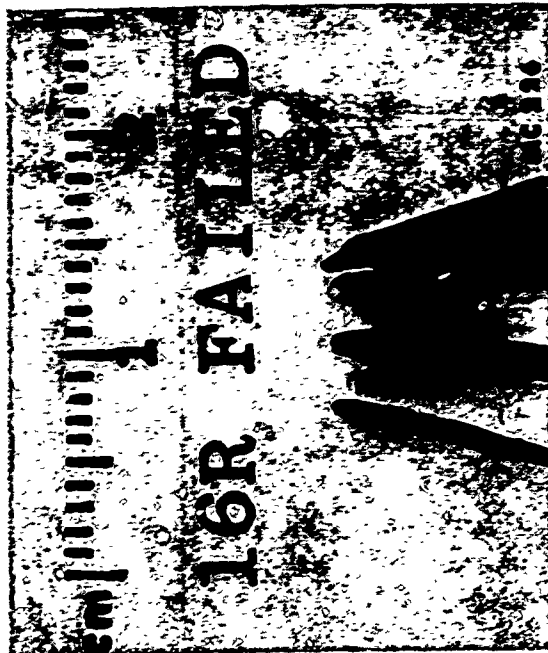
The contrast in performance of the risers beneath the intermediate buoys of the 030° and 270° legs is shown in Fig. 9. Data from the failed 150° leg riser are not shown because samples were not available. It is evident from Fig. 9 that the diameters of outer wires from the 030° leg riser were not drastically reduced, but the opposite effect was noted for the 270° leg riser which failed because of severe corrosion. The only apparent explanation for the divergent behavior of risers is that the 030° leg riser was relatively well protected by the bituminous coating (Table 2). A cross section of the 270° leg riser approximately 50 ft above the failure is shown in Fig. 10, and the appearance of failed ends of wires from this riser is shown in Fig. 11.

Fig. 11 - Failed ends of wires from the 270° leg intermediate buoy riser. Fracture appearance on individual wires varied and the diameter of some wires was severely reduced.

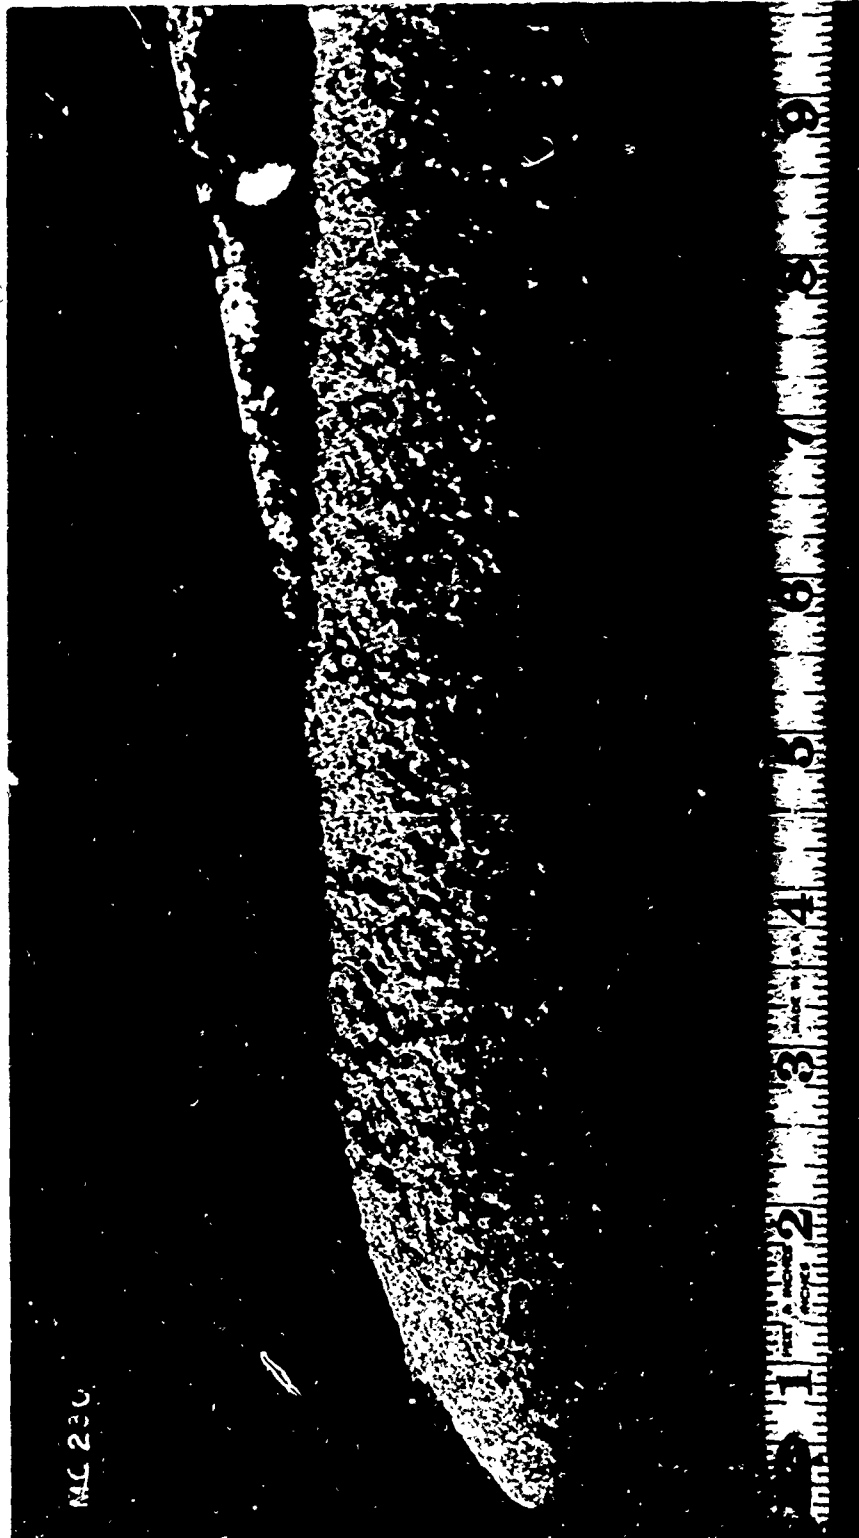
Since all available replacement anodes were salvaged, it was possible to obtain data concerning performance of the anodes which may be useful in future designs of cathodic protection systems for wire rope structures. One original 400-lb anode was also salvaged from the junction of the 150° lower catenary and the anchor chain. This anode is of particular interest because it functioned continuously for approximately five years at low temperature and high pressure at a depth of 5400 ft. The performance data for the anodes are summarized in Table 3.

Fig. 12 (continued) - Corrosion patterns on individual magnesium anodes from the TOTO II deep sea moor. Anodes shown in (a) through (c) functioned for 1.65 years at a depth of approximately 200 ft. The anode shown in (d) functioned for 5.12 years at a depth of approximately 5400 ft.

(d) Anode 60; estimated current density 445 ma/sq ft.
